Manhole Inspection Summary

Manhole # S45UU_011MH

Insp Date: **2/6/07 10:33 AM**

Location Address: **2884 HILLEN RD**

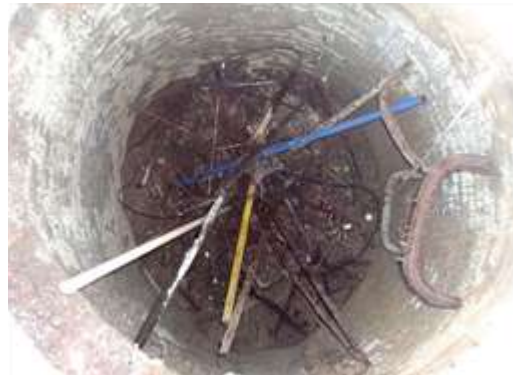
Top View

Corroded steps. Channel debris.

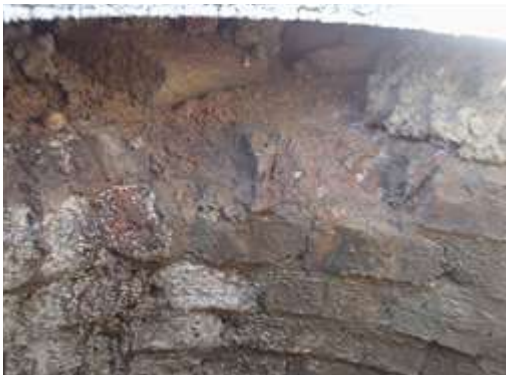
Defect

Condition: ☐ Sound ☐ Cracked ☐ Root Intrusion ☐ Loose Brick ☒ **Deteriorated**

Infiltration: ☐ None ☒ **Joint** ☐ Cracks ☐ Mortar ☐ Roots ☒ **Wall**

Adjustment deterioration and infiltration.

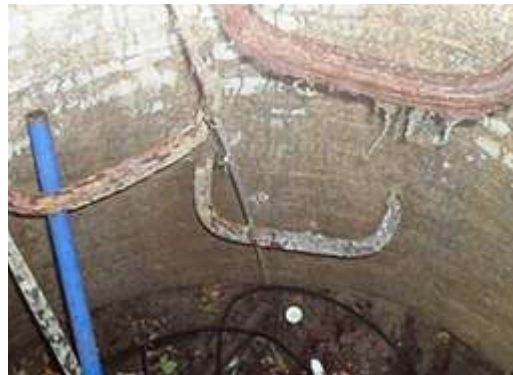
Defect

Infiltration: ☐ None ☐ Joint ☐ Cracks ☐ Mortar ☐ Roots ☒ **Wall**

Barrel infiltration.

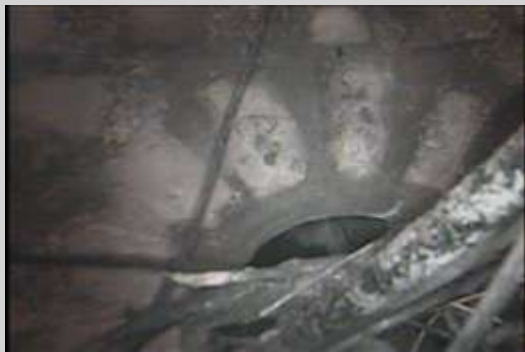
8 in. Circular Gravity Sewer
Pipe Out @ 12 O'Clock

Deposits: ☐ None ☒ **Mud** ☐ Sludge ☒ **Debris** ☐ Grease

Silt Depth: **6** (in.) Deposits Extent: **Heavy**

Infiltration: **Evidence** Pipe Seal Cond: **Unknown**
